M109A6 Paladin . . .

Snub the Rub!

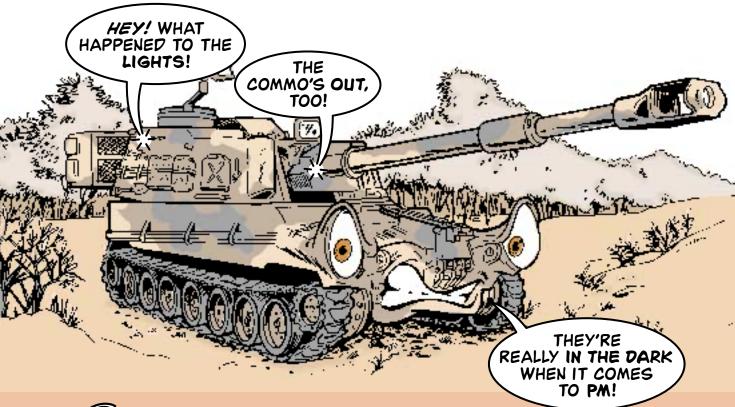
segment board on your Paladin, you're supposed to remove the green pad from the cleaning block. Just make **very** sure that you get the block locked back down on the cleaning mechanism afterward.

If it's not locked down properly, vibration makes the cleaning block pop up. In that position, the cleaning block rubs against the segment board until—zap!—the segment board shorts out. You're left without turret power or commo.

Ensure the cleaning block is locked down by eyeballing it. Look for a slight gap between the cleaning block and the cleaning mechanism. A gap means the

cleaning
block is
not locked
down.
Try again.
No
gap? The
cleaning
block is
locked

down and you're good to go.
